PRE-DEMOLITION ASBESTOS/HAZARDOUS MATERIALS SURVEY

Report Date:	November 29, 2017		
Client:	Genesee County Land Bank Authority		
Project No:	11785s-3-194		
Site Location:	902 North Stevenson Street	Parcel No. 40-12-354-032	
Inspection Date:	November 10, 2017	Building Square Footage:	1,250 SF (Total)
Inspector:	Mark Breeden Accreditation A44842	Signature:

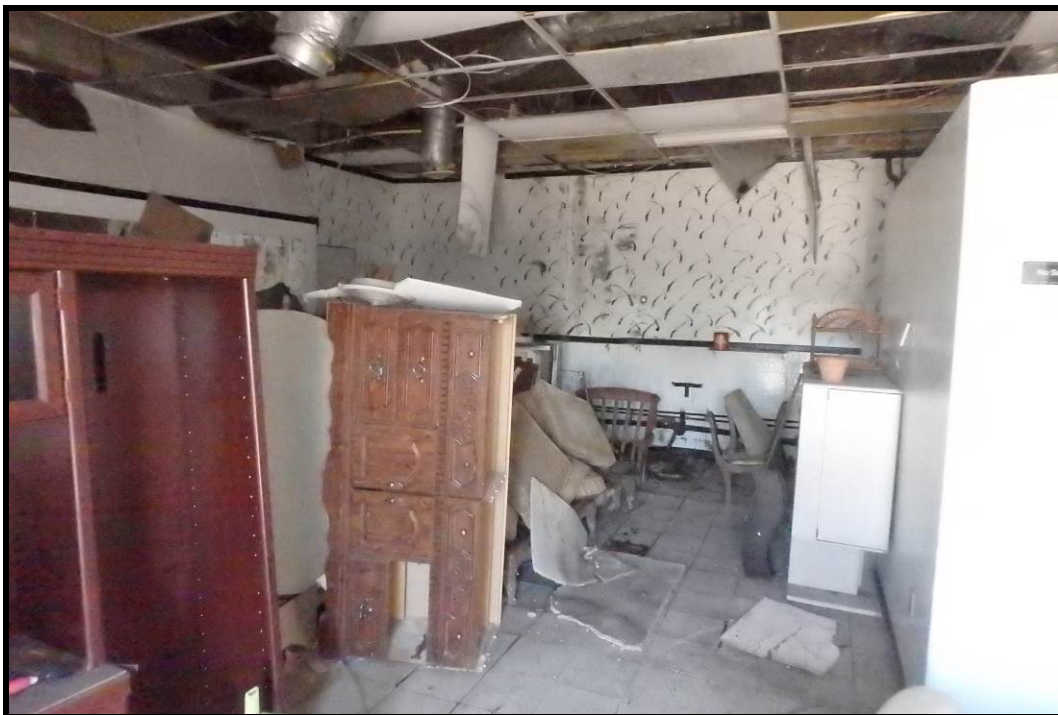
INTERIOR VIEW OF SUBJECT BUILDING

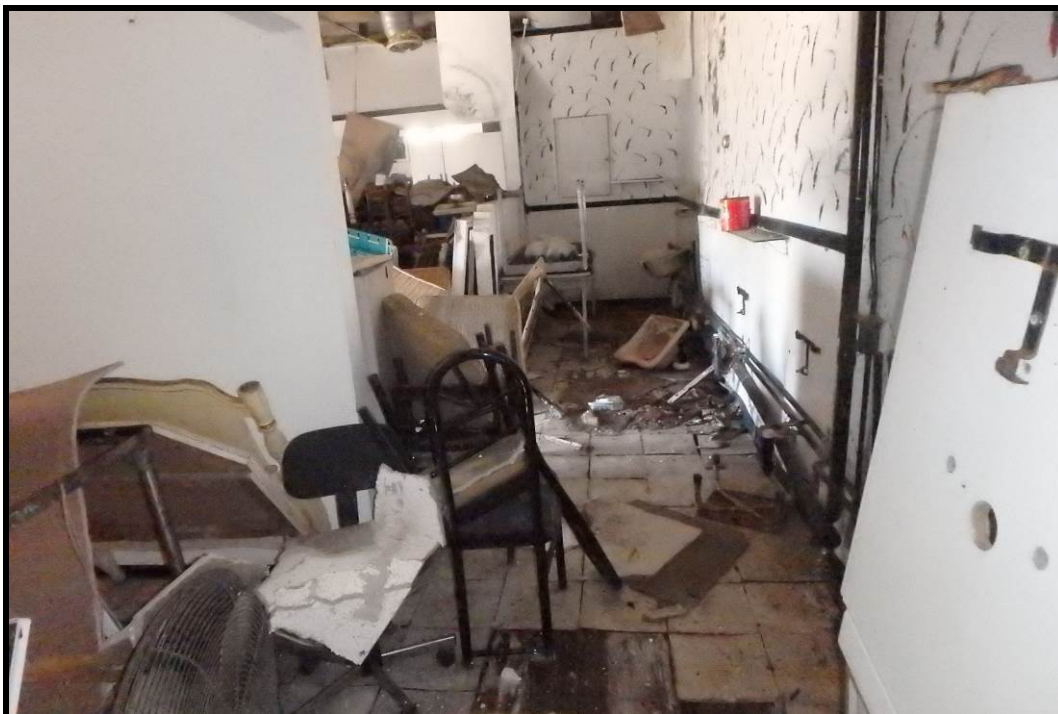
INTERIOR VIEW OF SUBJECT BUILDING

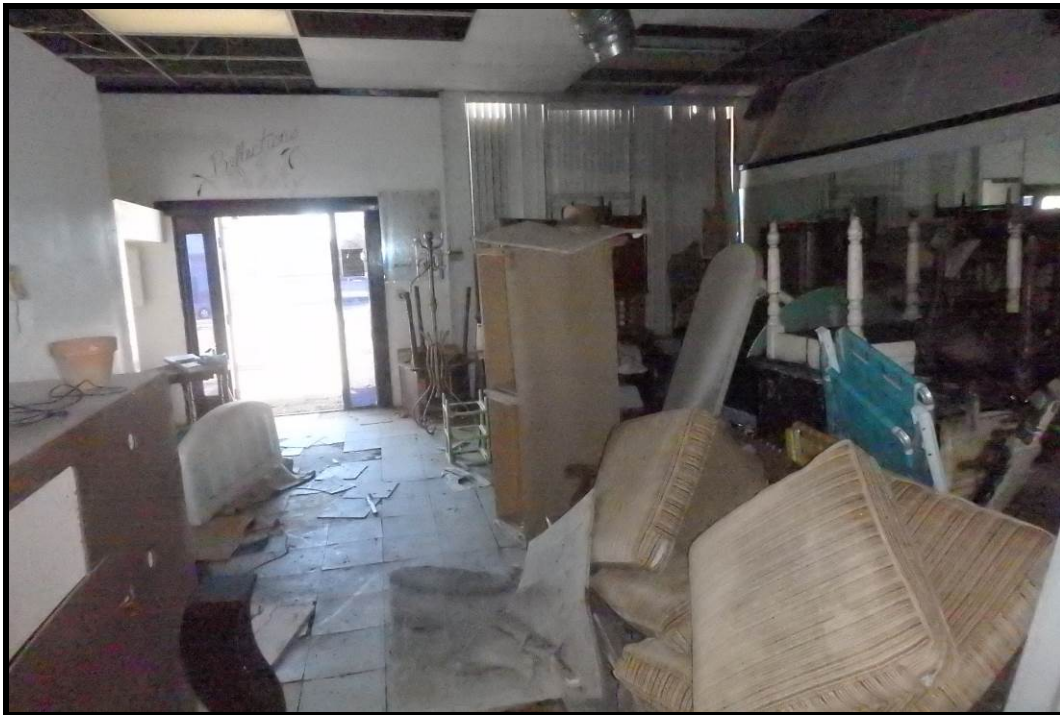
INTERIOR VIEW OF SUBJECT BUILDING

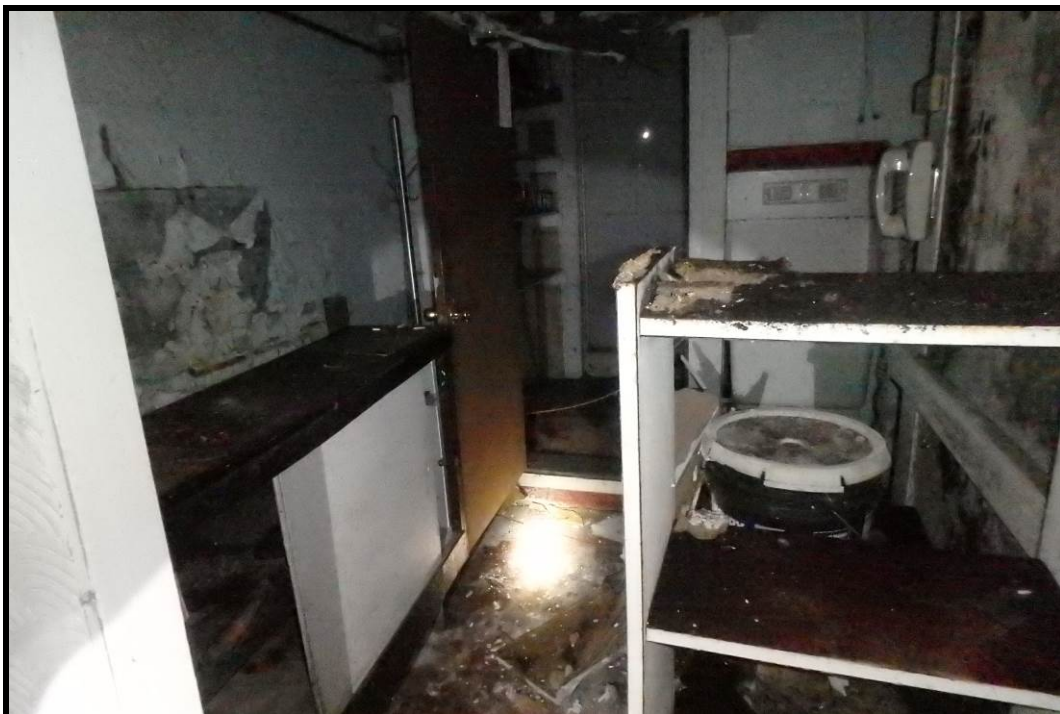
INTERIOR VIEW OF SUBJECT BUILDING
